Manhole Inspection Summary

Manhole # S35A__016MH

Location Address: **side 501 n charles st**

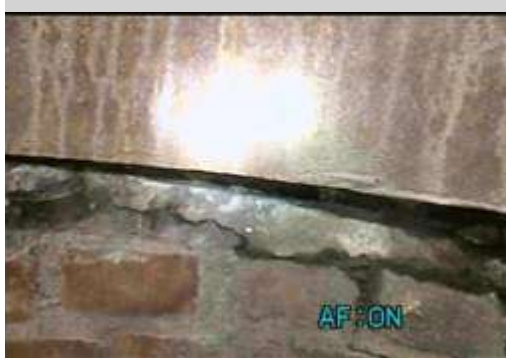
Defect 3

Condition: ☐ Sound ☒ **Cracked** ☐ Root Intrusion ☐ Loose Brick ☐ Deteriorated

crack between frame & chimney

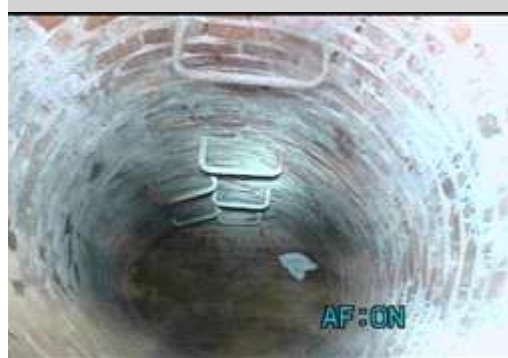
Defect 2

Count: **7** Missing: **0** ☒ **Corroded**

corr steps

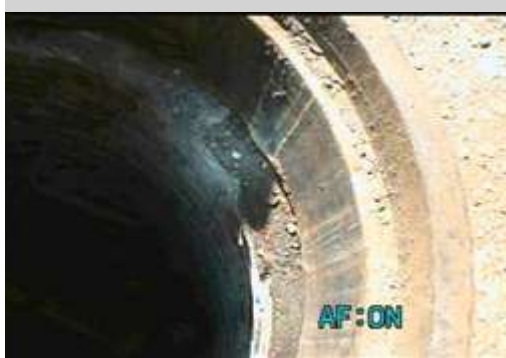
Defect 1

Offset: **2** (in.)

offset

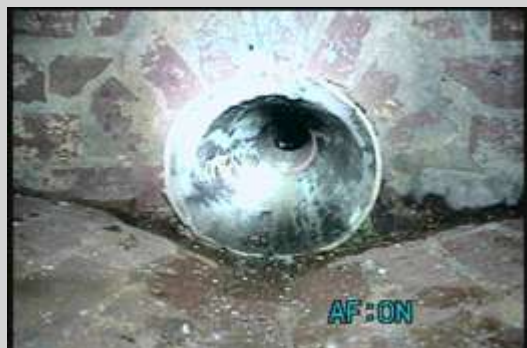
12 O'Clock Outflow

8 in. Circular Gravity Sewer
Pipe Out @ 12 O'Clock

Deposits: ☒ None ☐ Mud ☐ Sludge ☐ Debris ☐ Grease

Infiltration: **None** Pipe Seal Cond: **Unknown**
